THE INFLUENCE OF A LARGE REFLECTOR OVER THE ORCHESTRA PIT IN AN OPERA HOUSE

Tor Halmrast
Anders Buen
Gunnar Ihlen

Statsbygg, Oslo, Norway tor.halmrast@statsbygg.no
Brekke and Strand Acoustics, Oslo, Norway
Norwegian National Opera, Oslo, Norway

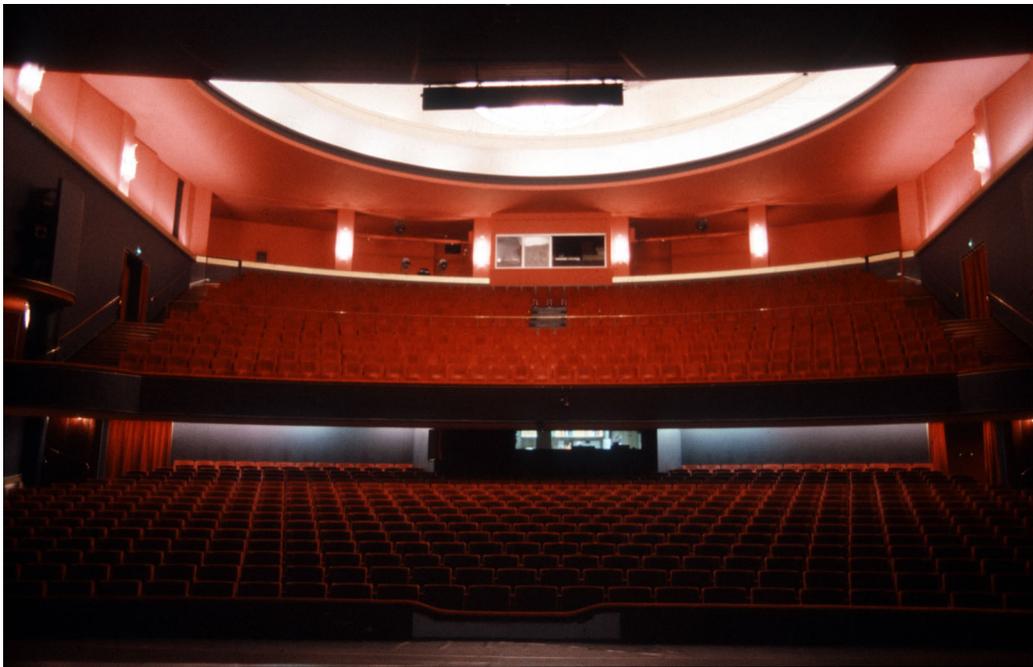
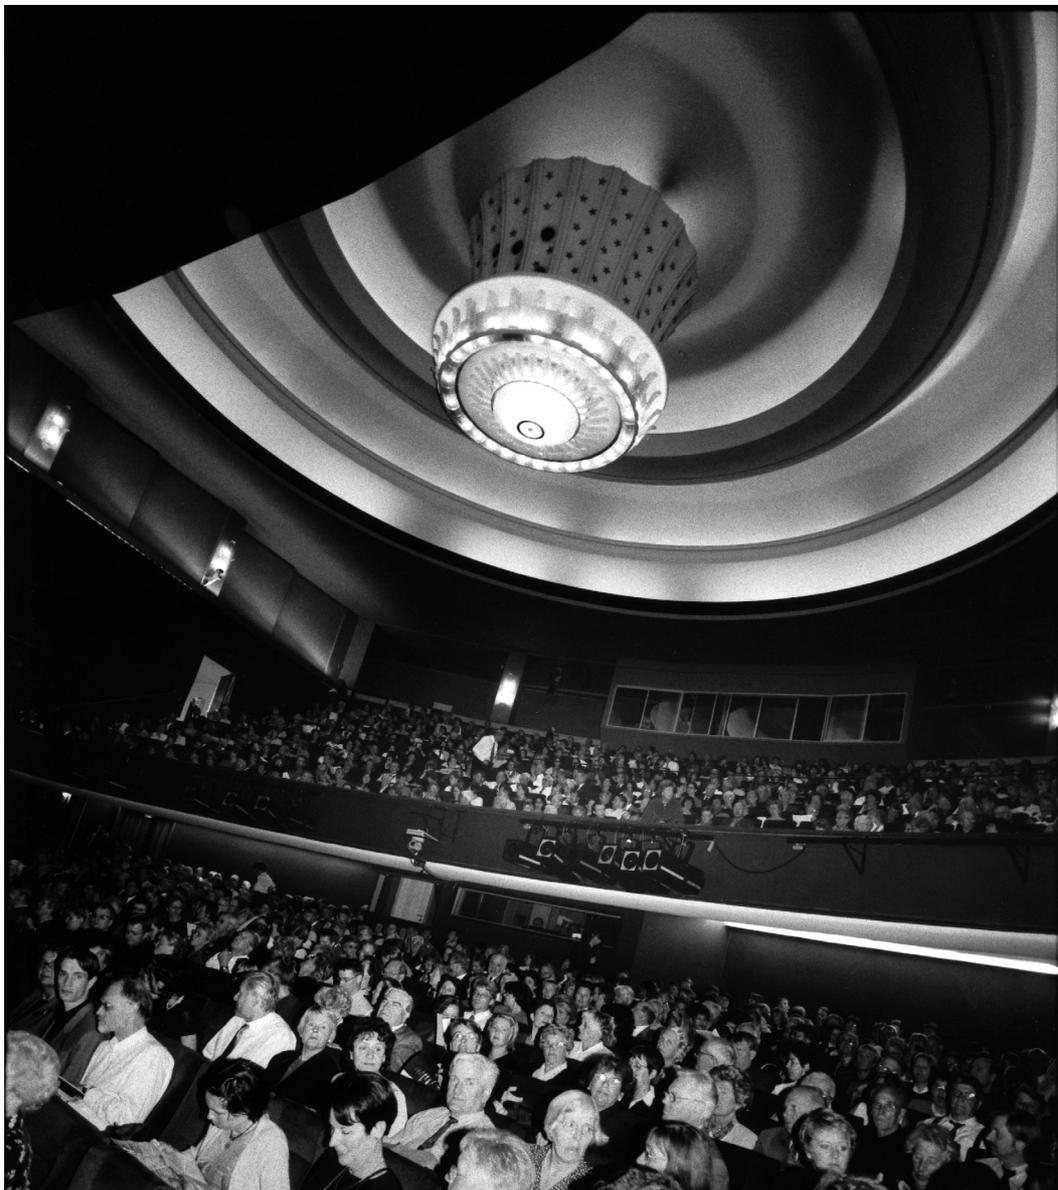
The following pictures show that the OLD, large reflector shaded a large part of the ceiling.

(Ceiling made in rabbitz, visually nice/acoustically strange)
